Cedar Mine

AUM Field Survey Data Sheet

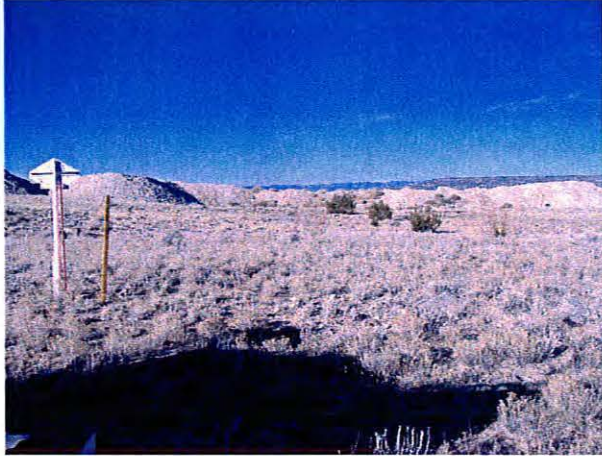
View west, pipeline marker, gravel pit in distance

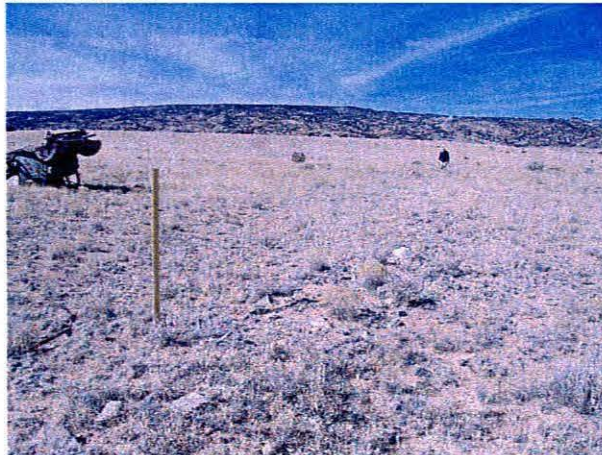
Equipment remaining on-site includes an old truck, an engine, and what appears to be a powder box.

View north, pipeline, old truck

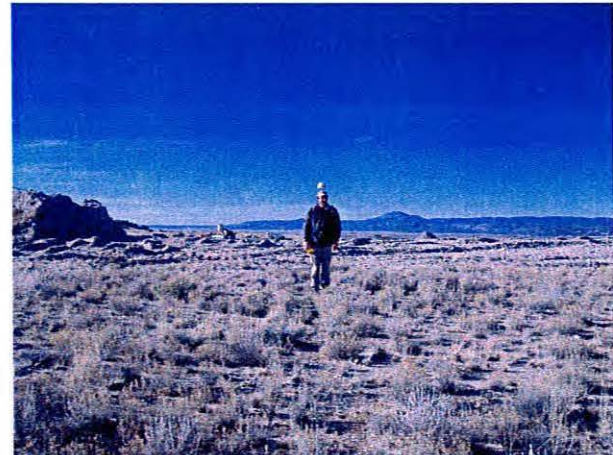
2. Human Activity: The Cedar Mine is directly adjacent to an active sand and gravel mining operation operated by B-b Concrete. Trash (heavy equipment, air filters, etc.) has been discarded on-site. A buried gas pipeline crosses the site in a north-south direction. The nearest residence is approximately 1,000 feet to the east of the site.

View southwest to sand and gravel op.

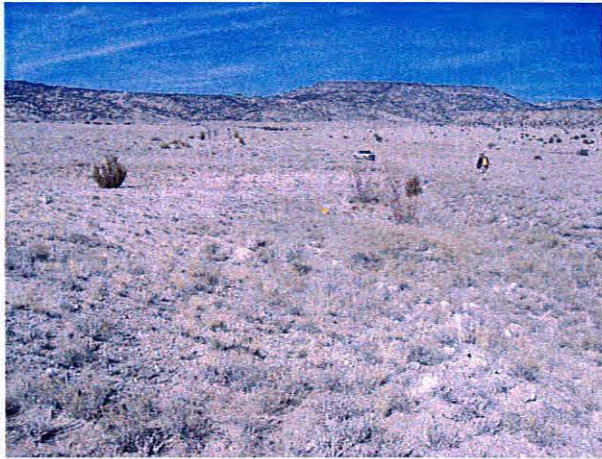
4. Mine Disturbance: The mine consists of seven lateral exploratory cuts extending east-west an average of 1,200 feet. To the west of these cuts are two shallow pits (one approximately 180 ft. in diameter by 10 ft. deep maximum, noted as large pit in photo, the other approximately 75 ft. by 25 ft., 3 ft depth), as well as two rock piles associated with the east-west cuts on the east margin of the site. These piles are 340 and 460 feet long respectively, approximately 4 feet wide and approximately two feet thick. A pile approximately 35 feet in diameter and three feet thick exists on the east margin of the site, and a pile approximately 15 feet in diameter and 2 ft. thick is present in the center of the site.

View of large pit
